THE PREDICTION OF STRUCTURAL FAILURES.

A thesis submitted to the University of
London for the degree of Doctor of Philosophy.

BY
PAUL SIBLY.

March . . 1977.

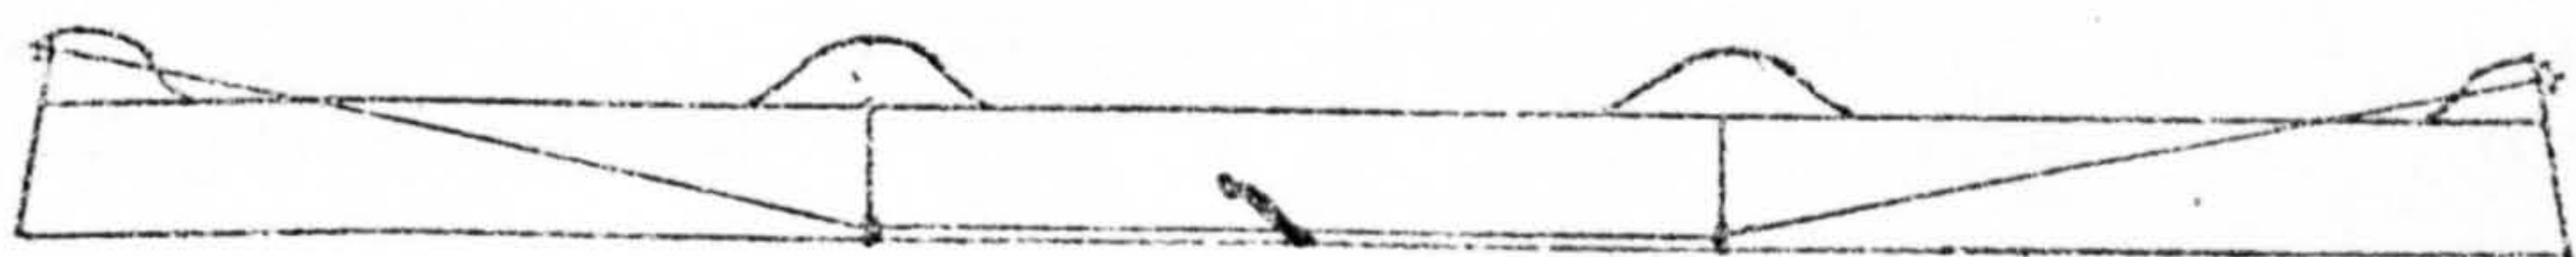
Fig 2.9. Wrought iron rods supporting cast iron girder after failure.

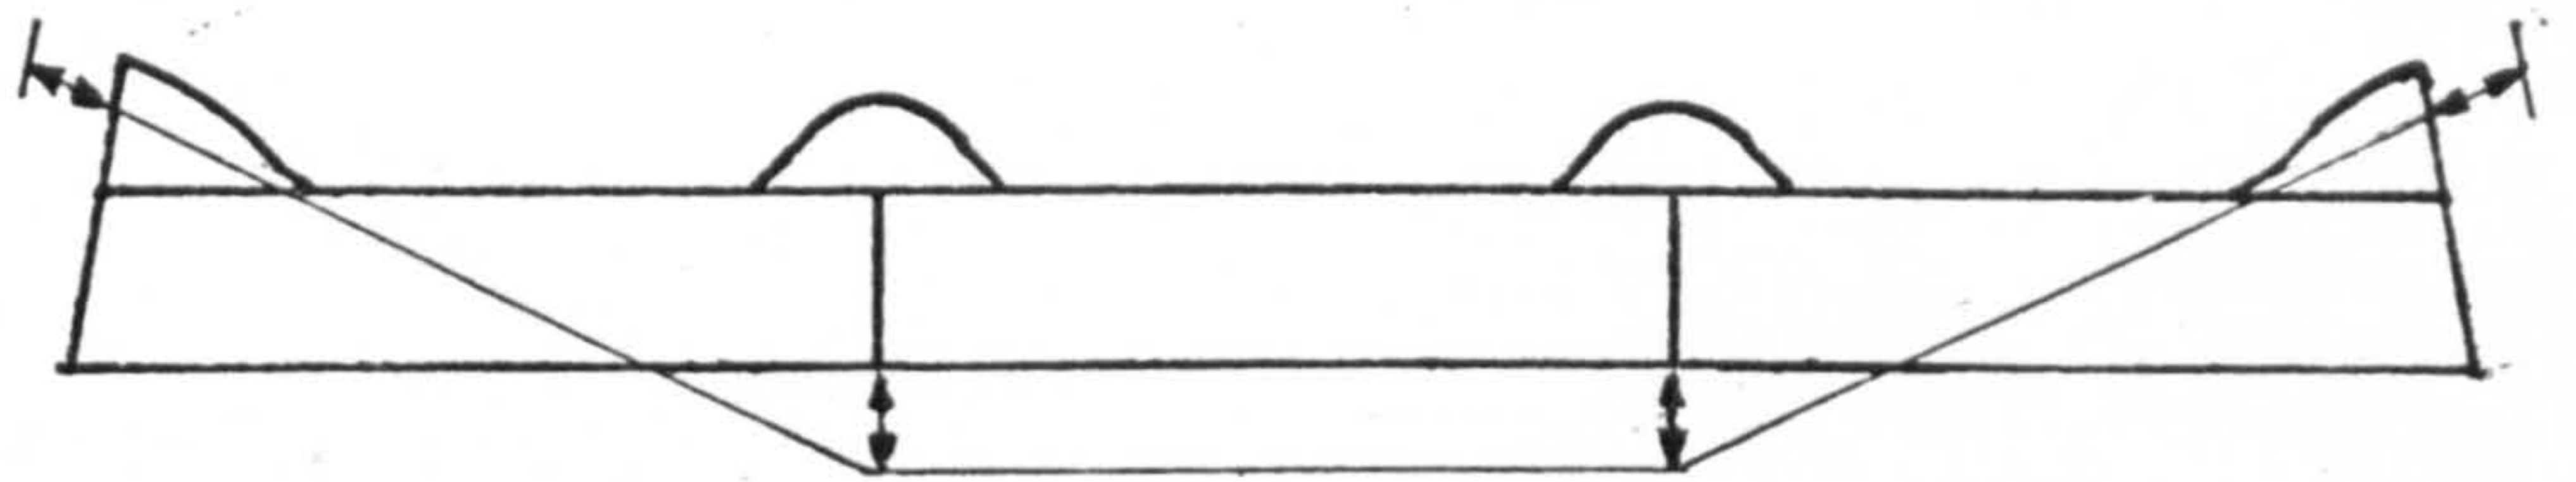
beams and static loading. No research had been done to investigate the effect of trussing the beam with wrought iron straps nor to assess the effect of varying the beam section, so the application of the design rule to this type of structure was fundamentally invalid. Nevertheless it was not considered necessary to assess the beam and truss interaction (fig.2.14) quantitatively when the design was made. Indeed before the stiffness method of structural analysis (pioneered by Navier in his "Résumé des leçons" in 1826) caught on in the late 1800s such work was difficult. As matters stood, the designer assumed that there would be a certain amount of beneficial composite action between the two systems and that the section of the cast iron could be reduced from that nominally required for carrying the whole load by bending action. The extent of the reduction was to make the strength of the cast iron beam only 1.55 times the design load instead of the more usual figure of 4 or 5.

Fig 2.I4. Interaction of beam and trussing.

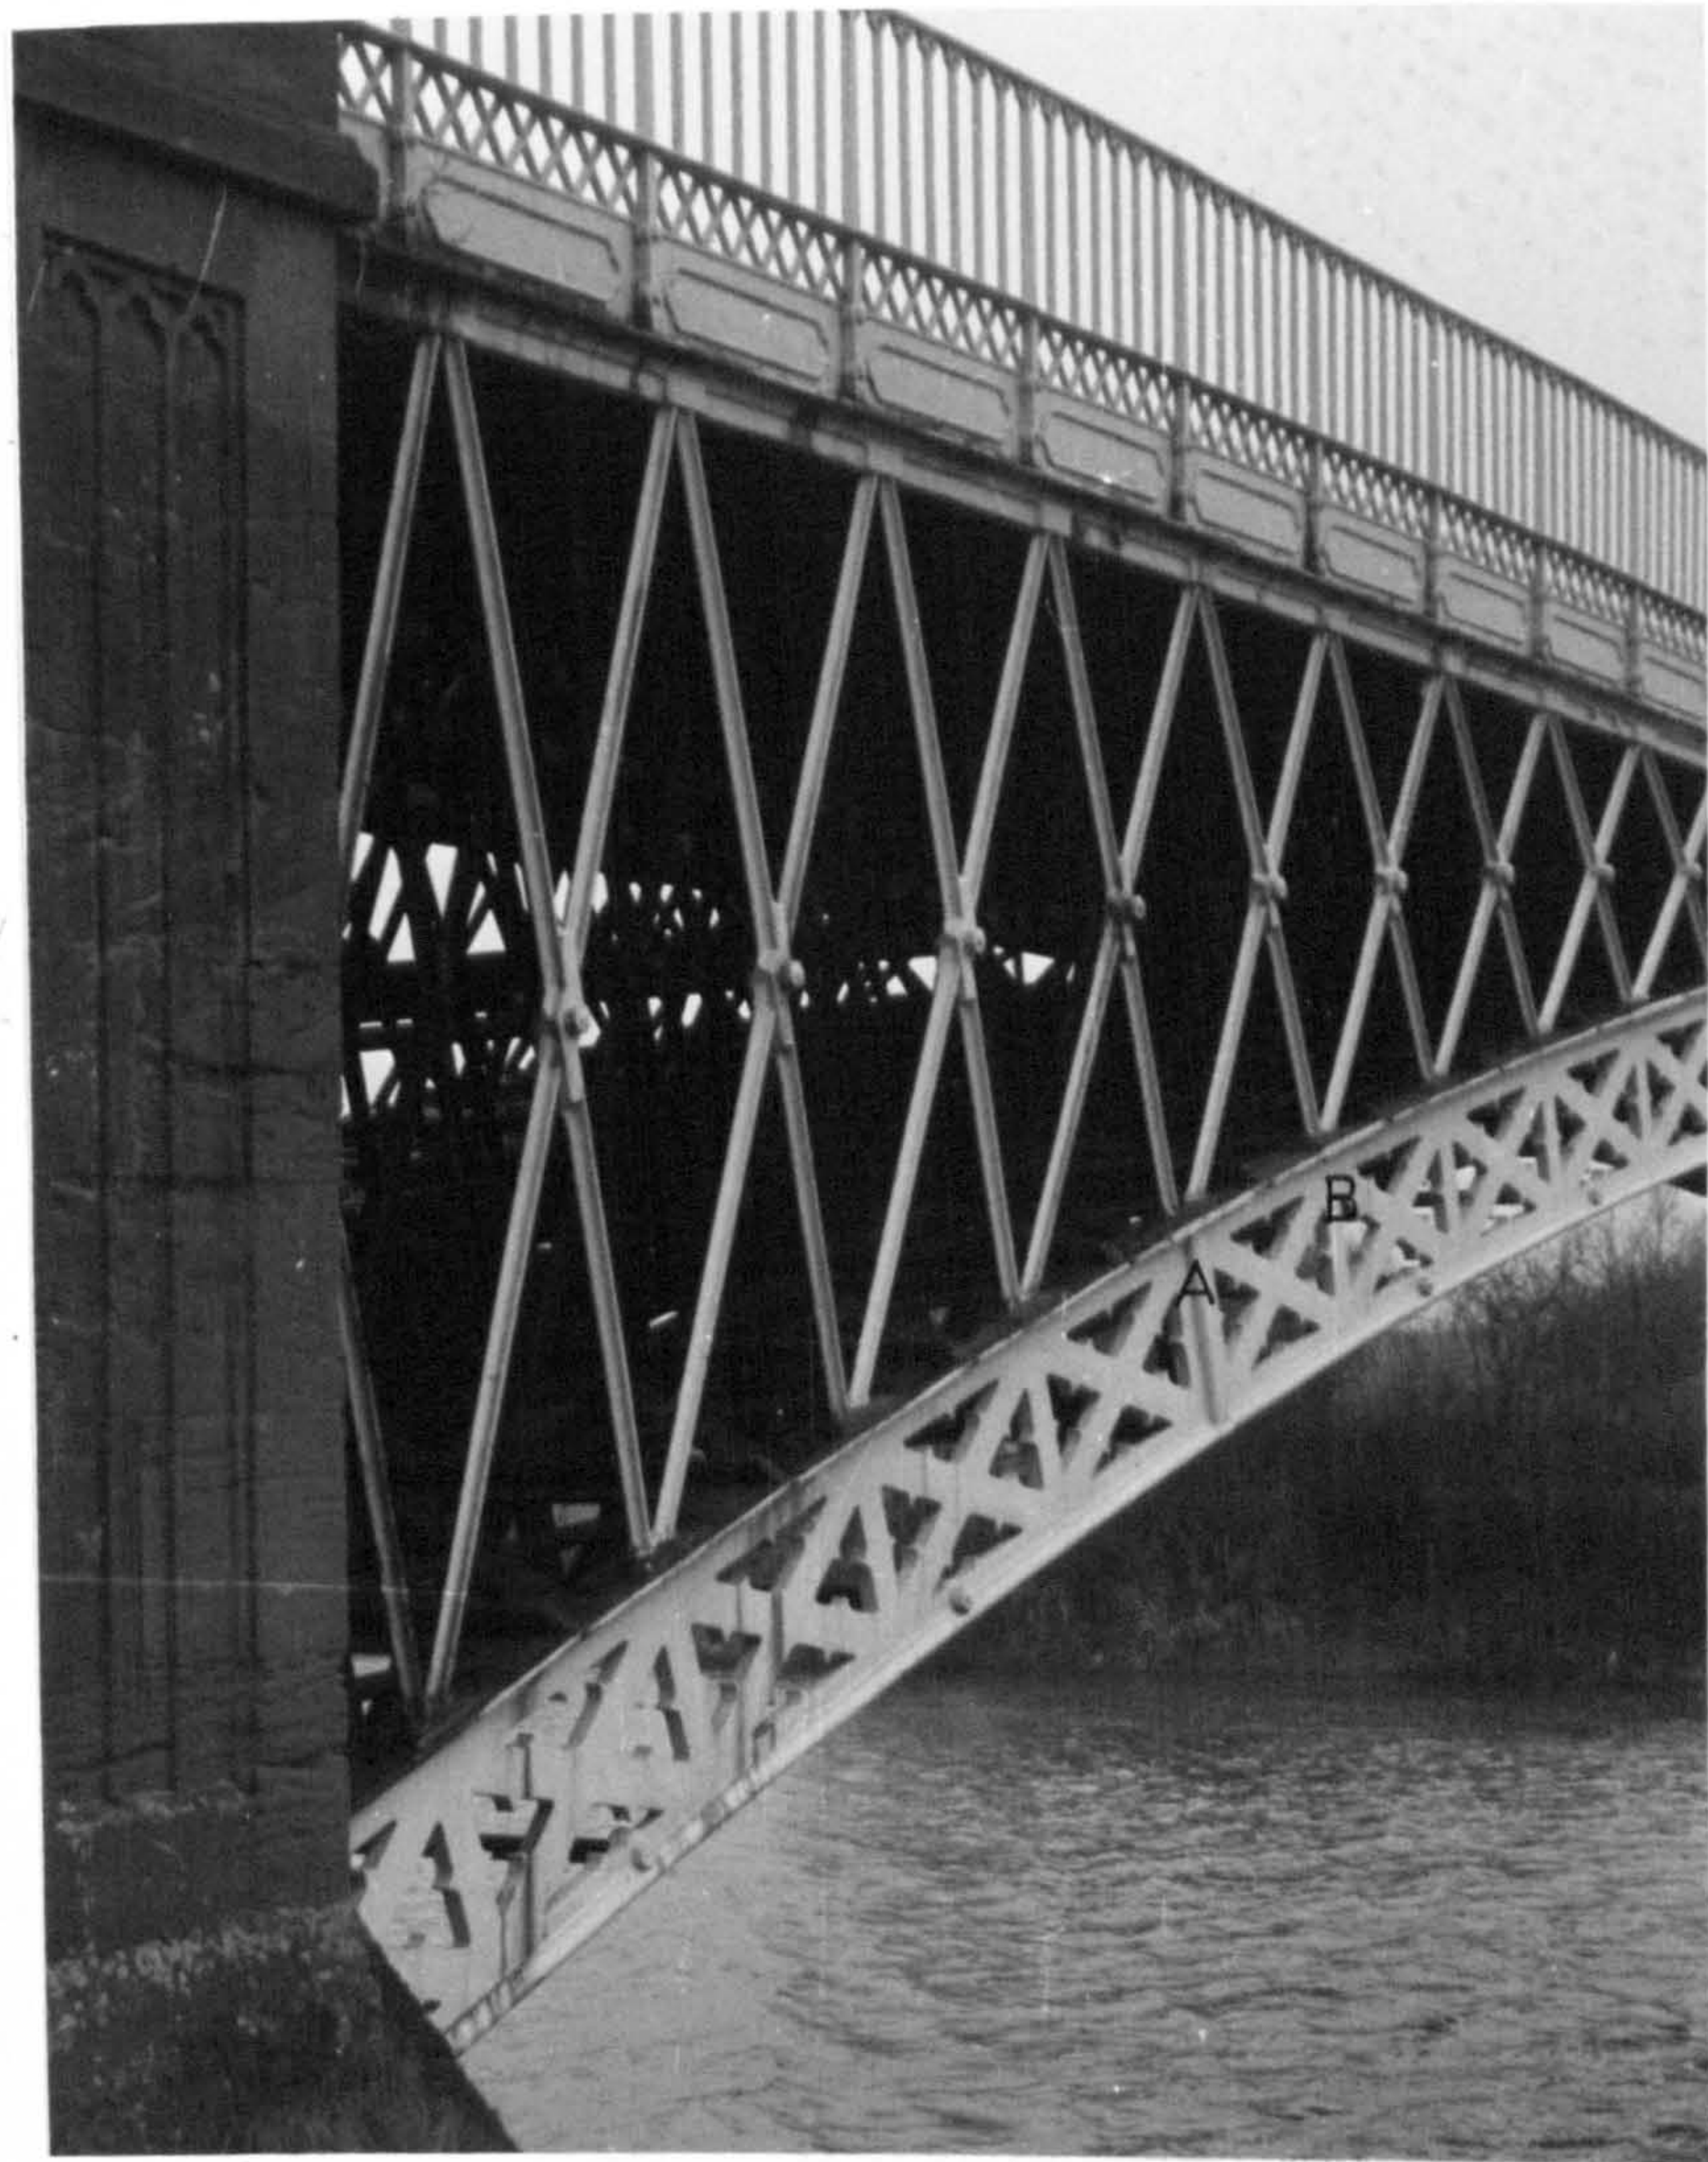
Fig 2.I5. Frost damage, Mythe bridge.

At A. and B. steel plates have been bolted onto the main arch ribs following local fracture due to water freezing in the sockets cast to receive the spandrel struts.

is quite likely that water froze in them during the only winter the bridge survived, causing local damage to the cast iron. The author has noticed similar damage on other early cast iron structures, notably Telford's Mythe Bridge at Tewkesbury (fig.2.15). Mention should also be made of the facts that the bridge abutments were built parallel to the flow of the river and that the railway was on a slight curve. The first of these matters has always been common enough practice although it means that one girder is loaded before the other. The curve of the rails added to the uneven distribution of loading on the girders, introducing a centrifugal force of about 3.3 kN (750lbsf) for a normal train as well as an uneven static distribution of load.¹³ A common way of counteracting these effects was by bracing the main girders firmly together, but the binding system applied to the Dee Bridge was flimsy and ineffective, consisting only of wrought iron ties dovetailed into sockets cast on the main girders.

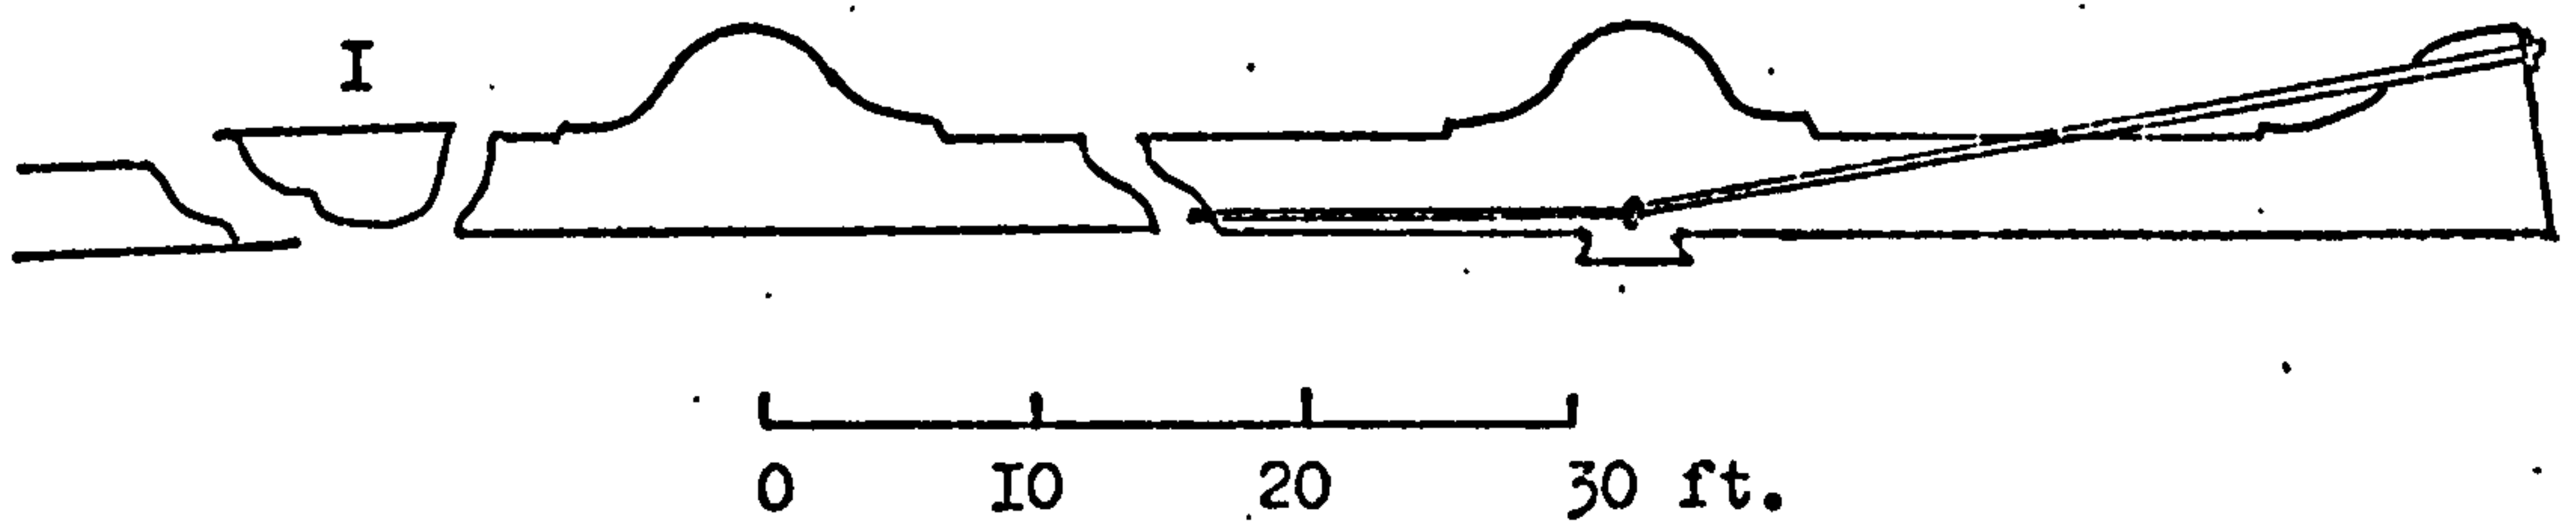
Fig 2.18. fractures of the broken Dee bridge girder.

Stephenson of course had to take a leading part in this. He inspected the wreckage on Thursday 27th May and immediately drew up a report for the Chester & Holyhead Directors.²⁰ After affirming his faith in the trussed girder principle he described the damage and came to the conclusion that fracture I in fig. 2.18 "...was precisely such as might be expected from a large piece of vertical rib being broken out of the girder and separated from the lower flange which remains perfect; a description of fracture which could scarcely be produced by a vertical action ...". He then clumsily manipulated evidence provided by the collapse to show that a carriage wheel had broken and caused a derailment resulting in either the tender or a coach hitting the girder at I with sufficient momentum to break out the shaded chunk of metal.

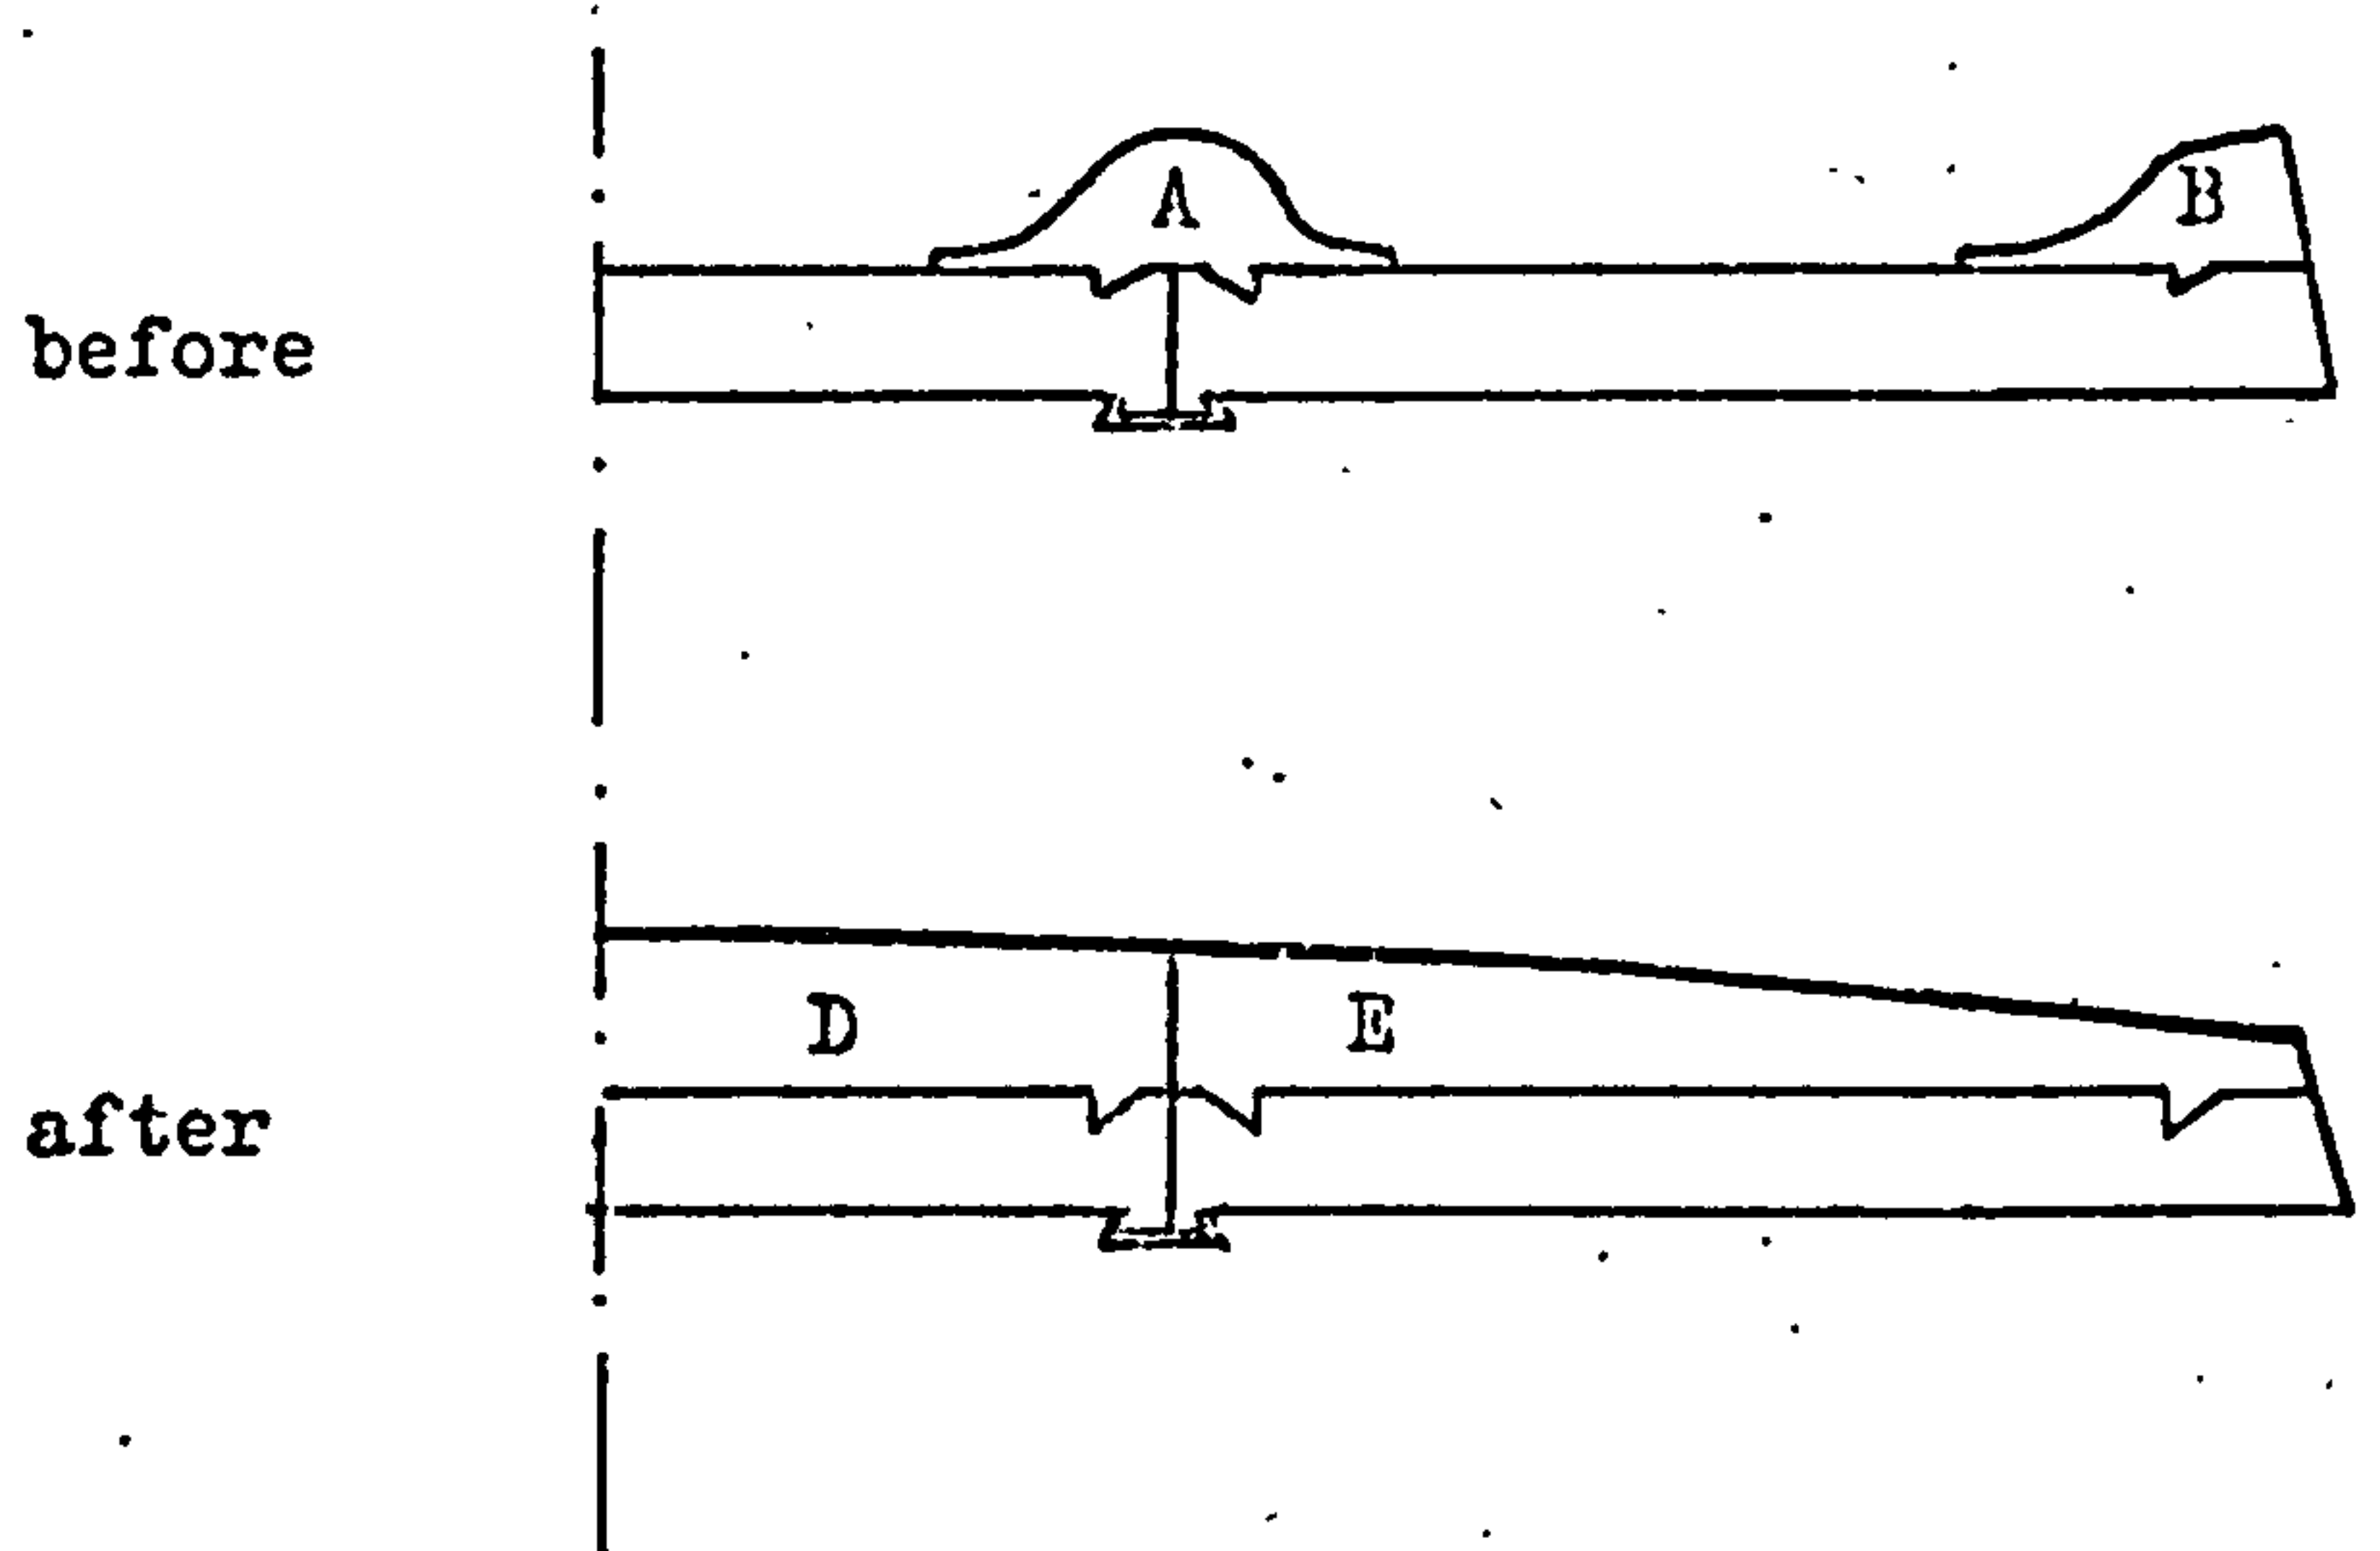
Fig 2.19. sketch of the modifying castings fitted to the Dee bridge girders.

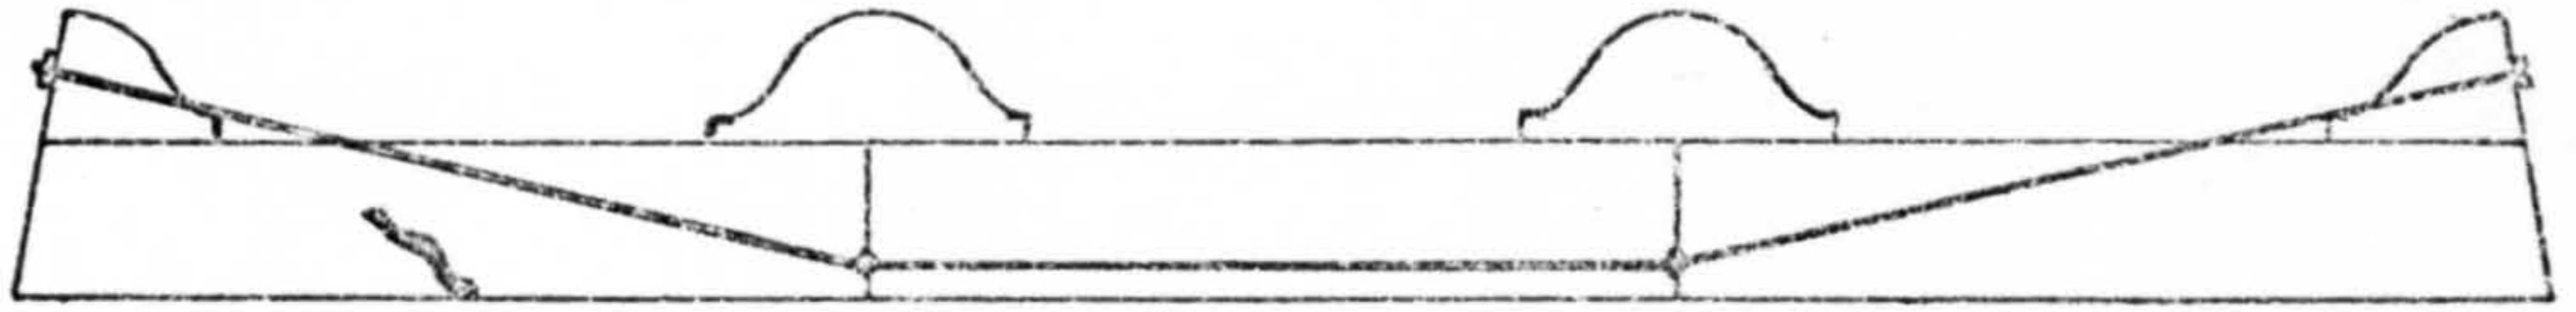
For the sake of clarifying the issue, the author reanalysed the girder along modern lines to see if the breaking load for a buckling mechanism would be lower than that required for a simple compression or tension failure. Fig. 2.20 shows the possible adjustments of the beam truss system and indicates the forces induced by tensioning. In a situation such as this with a small angle of inclination for the wrought iron rods, quite considerable horizontal forces can be induced by relatively little prestressing. This not only brings an undesirable addition to the bending moments in the end portions of the beam, but it also increases the compression forces in the top flange, as suggested by Robertson. The loading distribution that probably existed in the two systems is shown in fig. 2.20, and under these conditions the beam would have a factor of safety against lateral buckling approximately equal to one as a train passed overhead. It is therefore not surprising that the bridge collapsed. The failure probably began with the quarter point fracture along the line of weakness created by the holes cast in the compression flange for the proposed ornaments. Whereas with a fracture initiated in the middle third the wrought iron strapping might have saved the bridge, it could do nothing to prevent this type of failure being catastrophic (fig. 2.21). The onset of this mode of collapse would be aggravated by the manner in which the train and deck loads were transmitted to the girders with a twisting component.

Fig 2.21. Inability of tension rods to prevent failure in the end portions of a trussed girder.
